Manhole Inspection Summary

Manhole # S39KK_023MH

Insp Date: **1/18/08 12:04 PM**

Location Address: **1720 HOLBROOK ST**

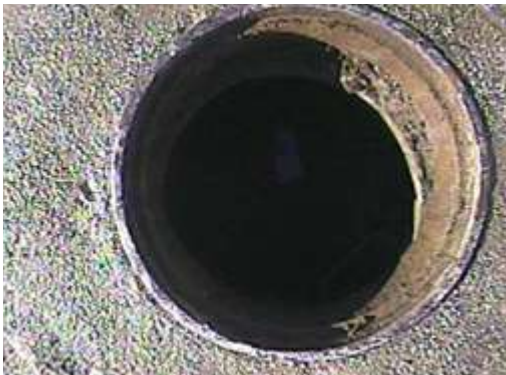
Defect 1

Frame Offset: **2** (in.) Condition: ☒ Sound ☐ Cracked ☐ Leaks

frame offset

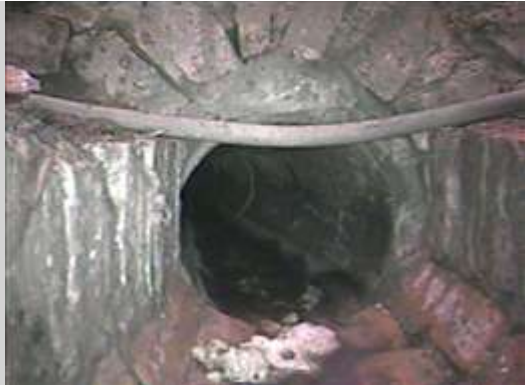
12 O'Clock Outflow

8 in. Circular Gravity Sewer
Pipe Out @ 12 O'Clock

Invert Depth: **8.01** (ft.) Flow Characteristics: **Slow**

Infiltration: **None** Pipe Seal Cond: **Sound**

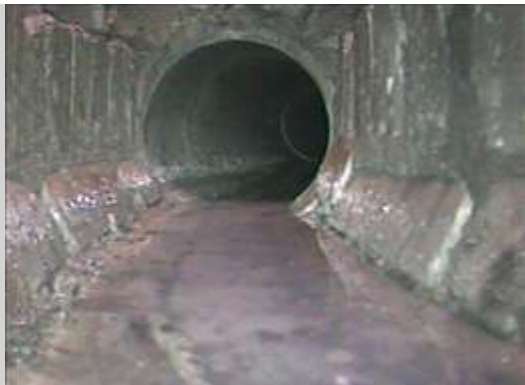
7 O'Clock Inflow

8 in. Circular Gravity Sewer
Pipe In @ 7 O'Clock

Invert Depth: **7.99** (ft.) Flow Characteristics: **Slow**

Infiltration: **None** Pipe Seal Cond: **Sound**
